Rapho Township  
Lancaster County, PA

**Figure III-3**  
**ACT 537 SEWERAGE FACILITIES PLAN**  
**Sporting Hill Area**

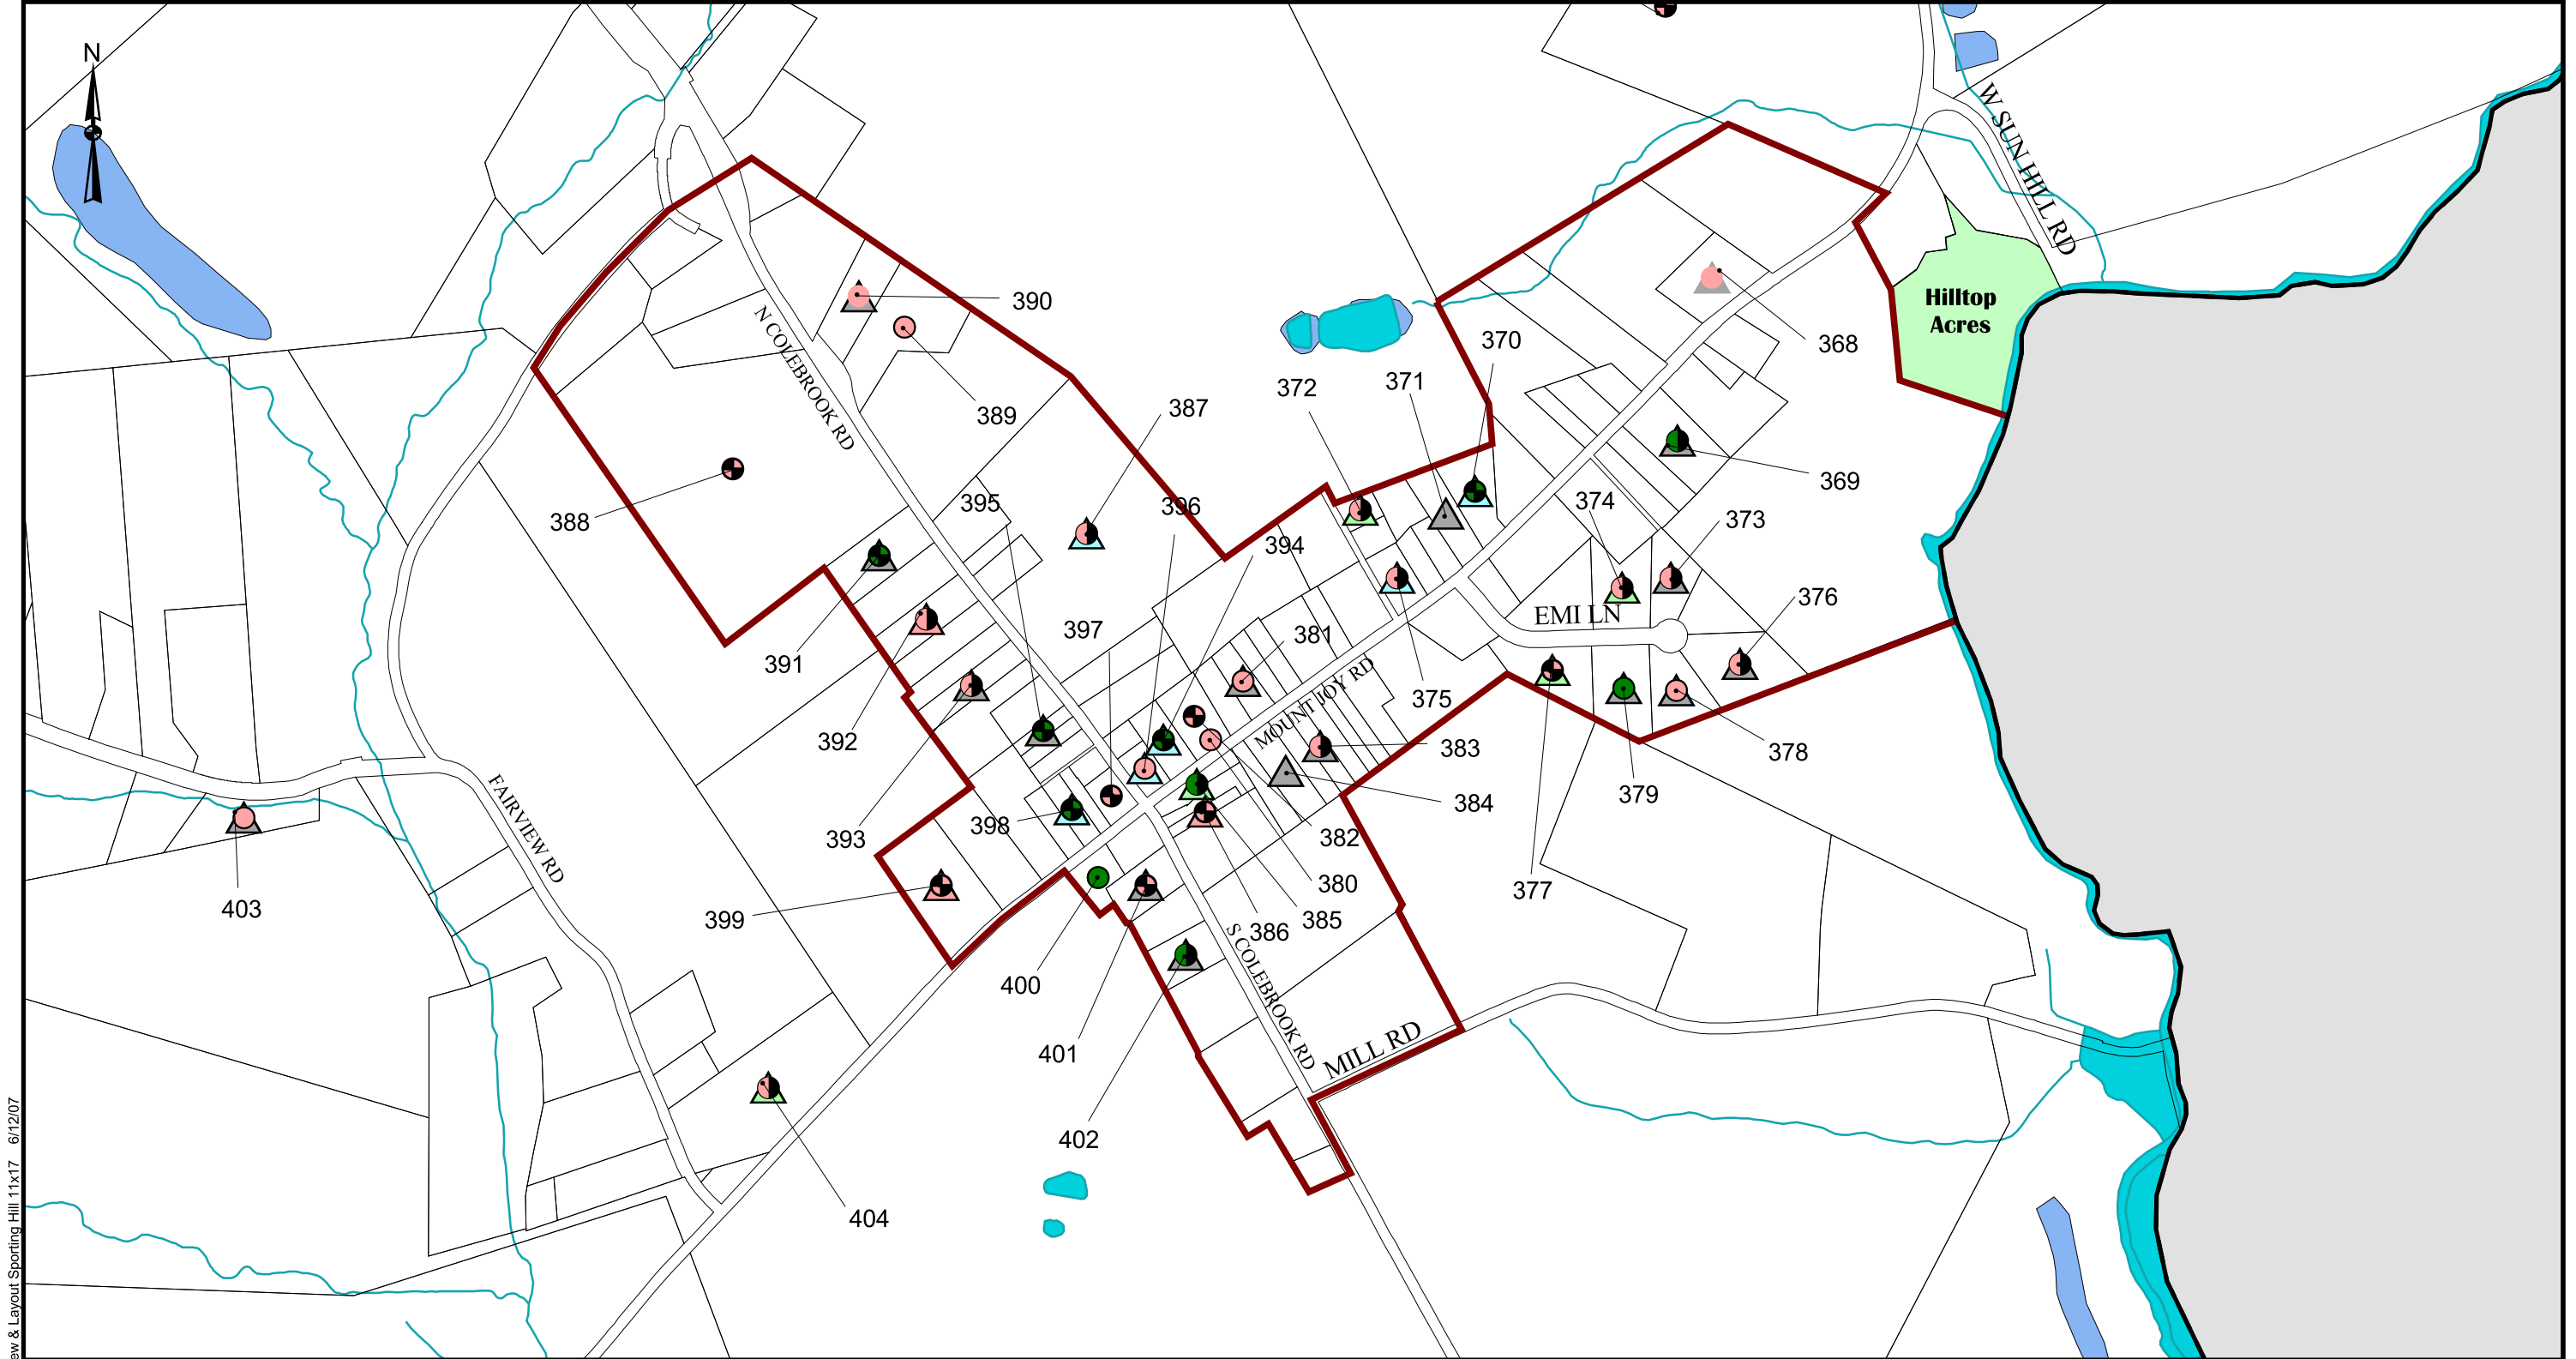
- Municipal Boundaries
- Wastewater Facilities
- OLDS Areas Evaluated
- Sewer Service Areas
- Floodplains
- Wetlands
- Parcels
- Bodies of Water

- WELL RESULTS**
- Wells with no Bacteria Detected and Nitrate Levels < 5 mg/l
  - Wells with no Bacteria Detected and Nitrate Levels 5-10 mg/l
  - Potential Malfunction Wells with no Bacteria Detected and Nitrate Levels > 10 mg/l
  - Wells with Bacteria Detected and Nitrate Levels < 5 mg/l
  - Wells with Bacteria Detected and Nitrate Levels 5-10 mg/l
  - Potential Malfunction Wells with Bacteria Detected and Nitrate Levels > 10 mg/l

- SANITARY SURVEY RESULTS**
- Confirmed Malfunction
  - Suspected Malfunction
  - Potential Malfunction
  - No Detected Malfunction
