Rapho Township
 Lancaster County, PA

Figure III-2
ACT 537 SEWERAGE
FACILITIES PLAN
Newtown Area
 Prepared by

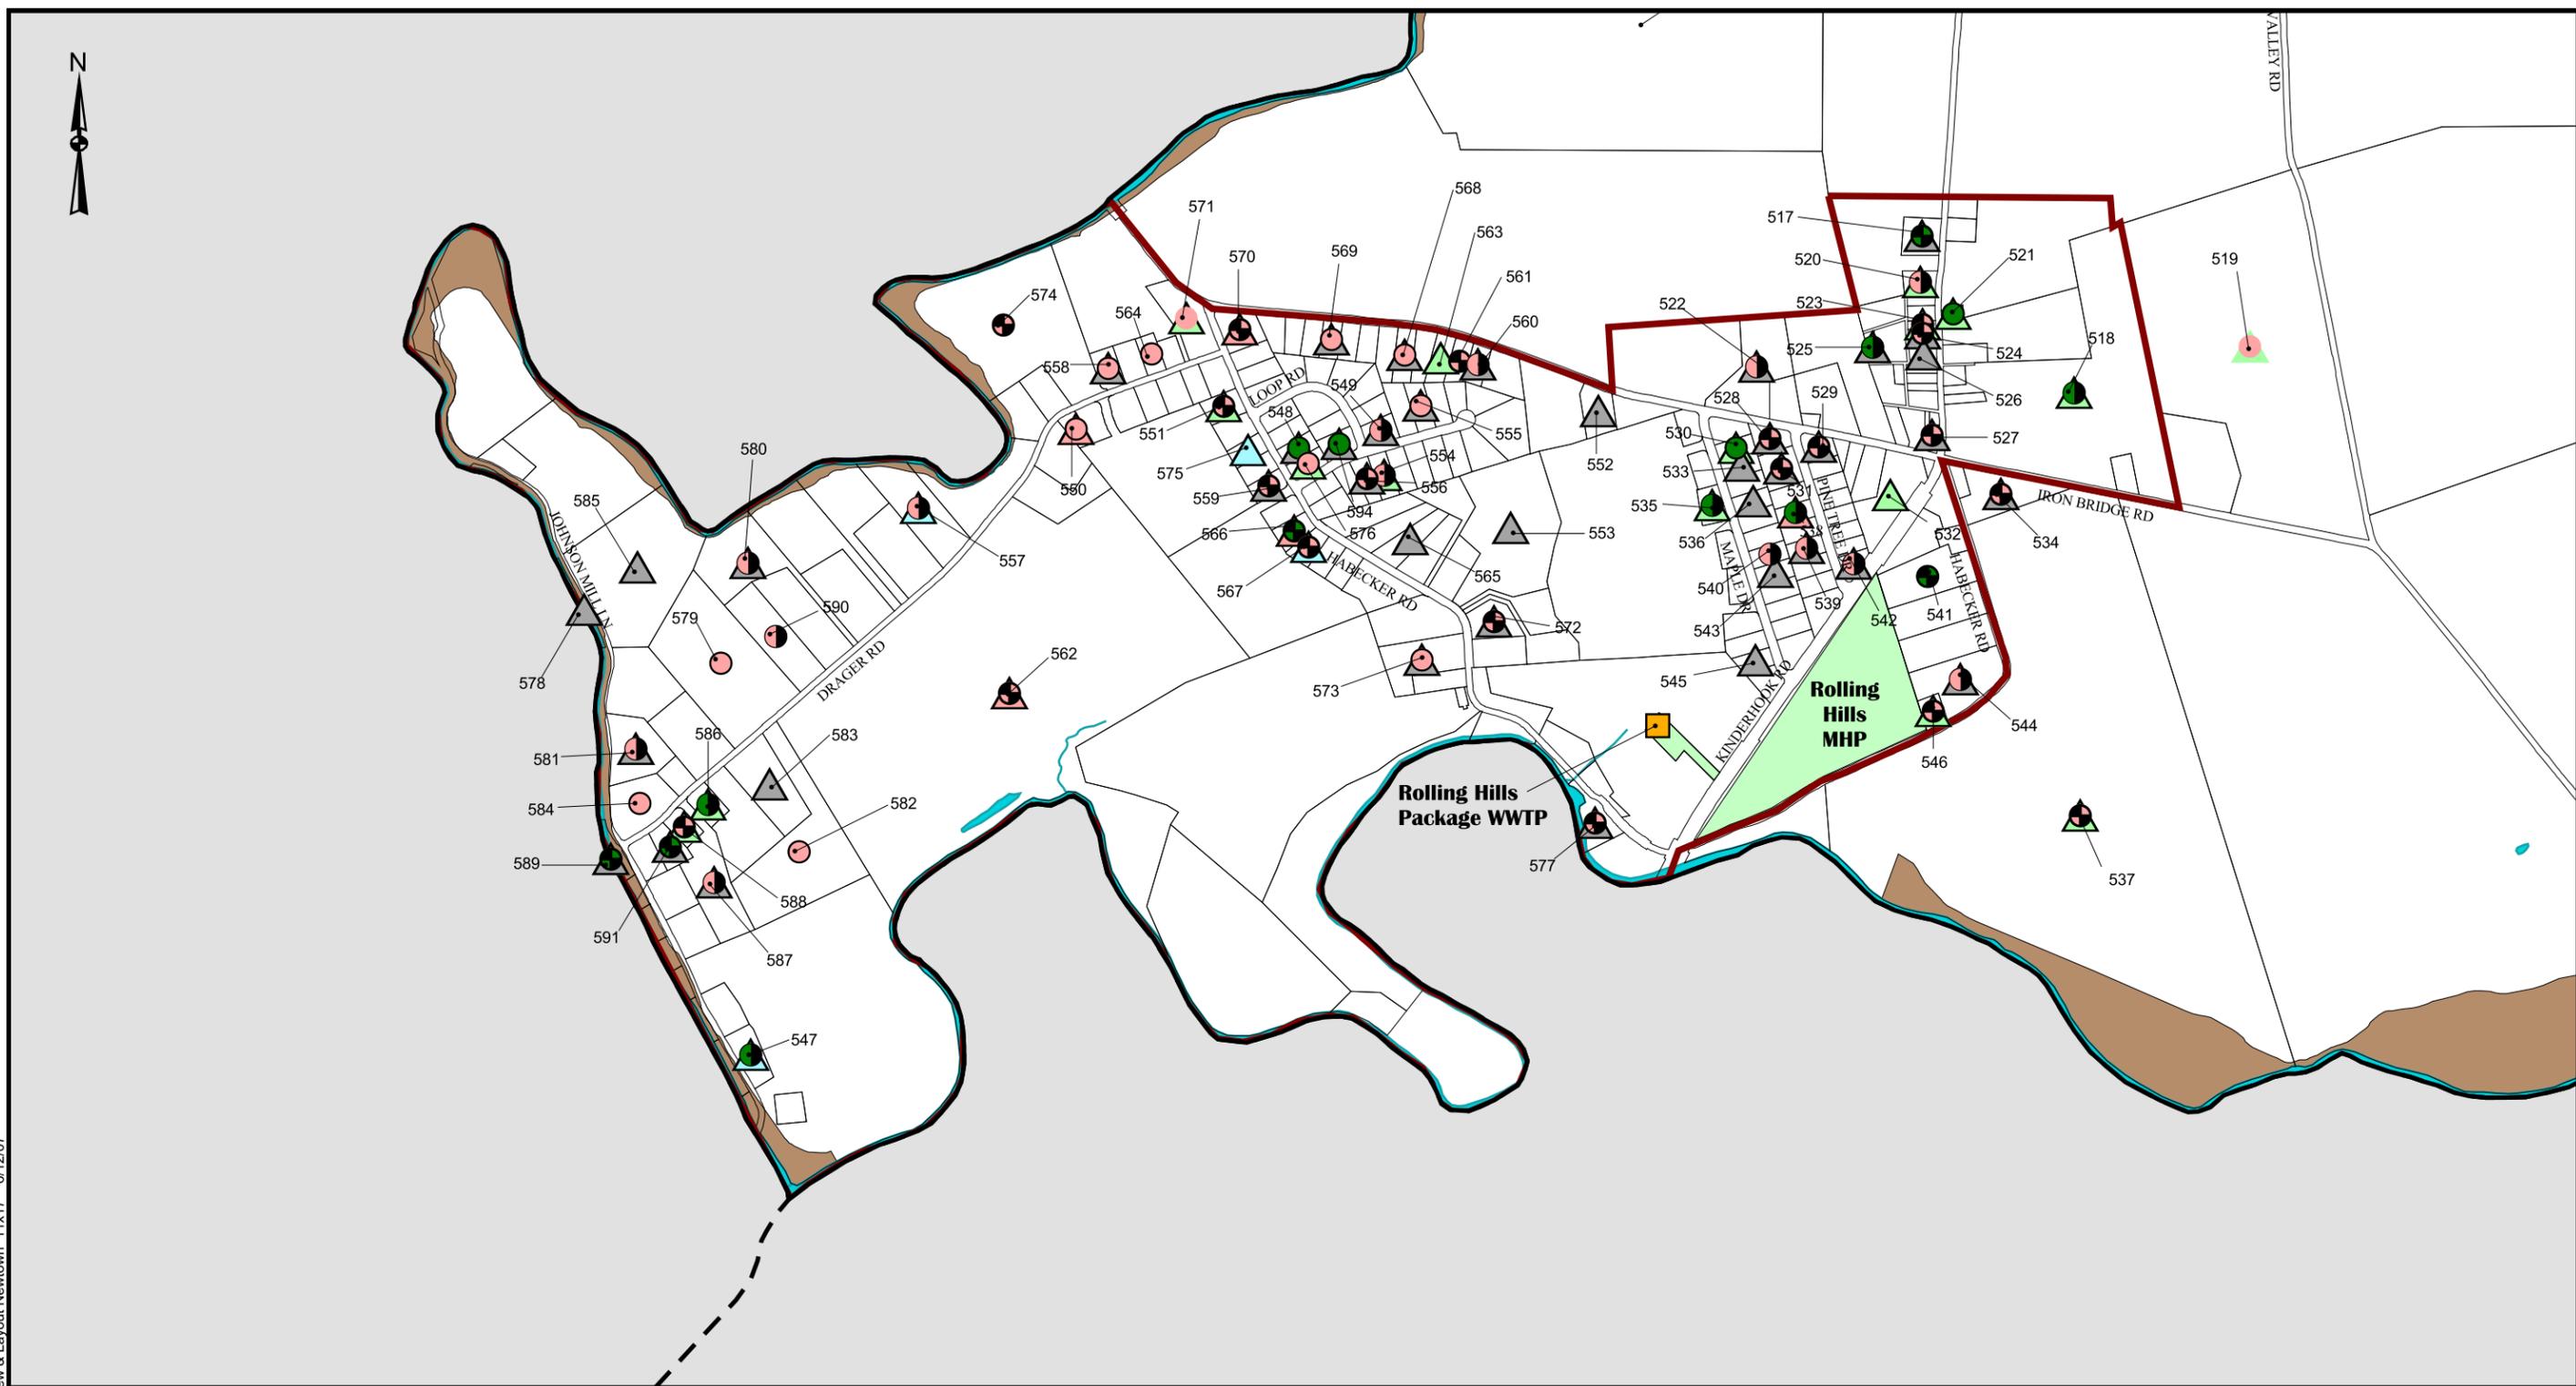
- WELL RESULTS**
- Wells with no Bacteria Detected and Nitrate Levels < 5 mg/l
 - Wells with no Bacteria Detected and Nitrate Levels 5-10 mg/l
 - Potential Malfunction Wells with no Bacteria Detected and Nitrate Levels > 10 mg/l
 - Wells with Bacteria Detected and Nitrate Levels < 5 mg/l
 - Wells with Bacteria Detected and Nitrate Levels 5-10 mg/l
 - Potential Malfunction Wells with Bacteria Detected and Nitrate Levels > 10 mg/l

- SANITARY SURVEY RESULTS**
- Confirmed Malfunction
 - Suspected Malfunction
 - Potential Malfunction
 - No Detected Malfunction
