Rapho Township
Lancaster County, PA

Figure III-4
ACT 537 SEWERAGE
FACILITIES PLAN
Mastersonville Area

Prepared by ARRO

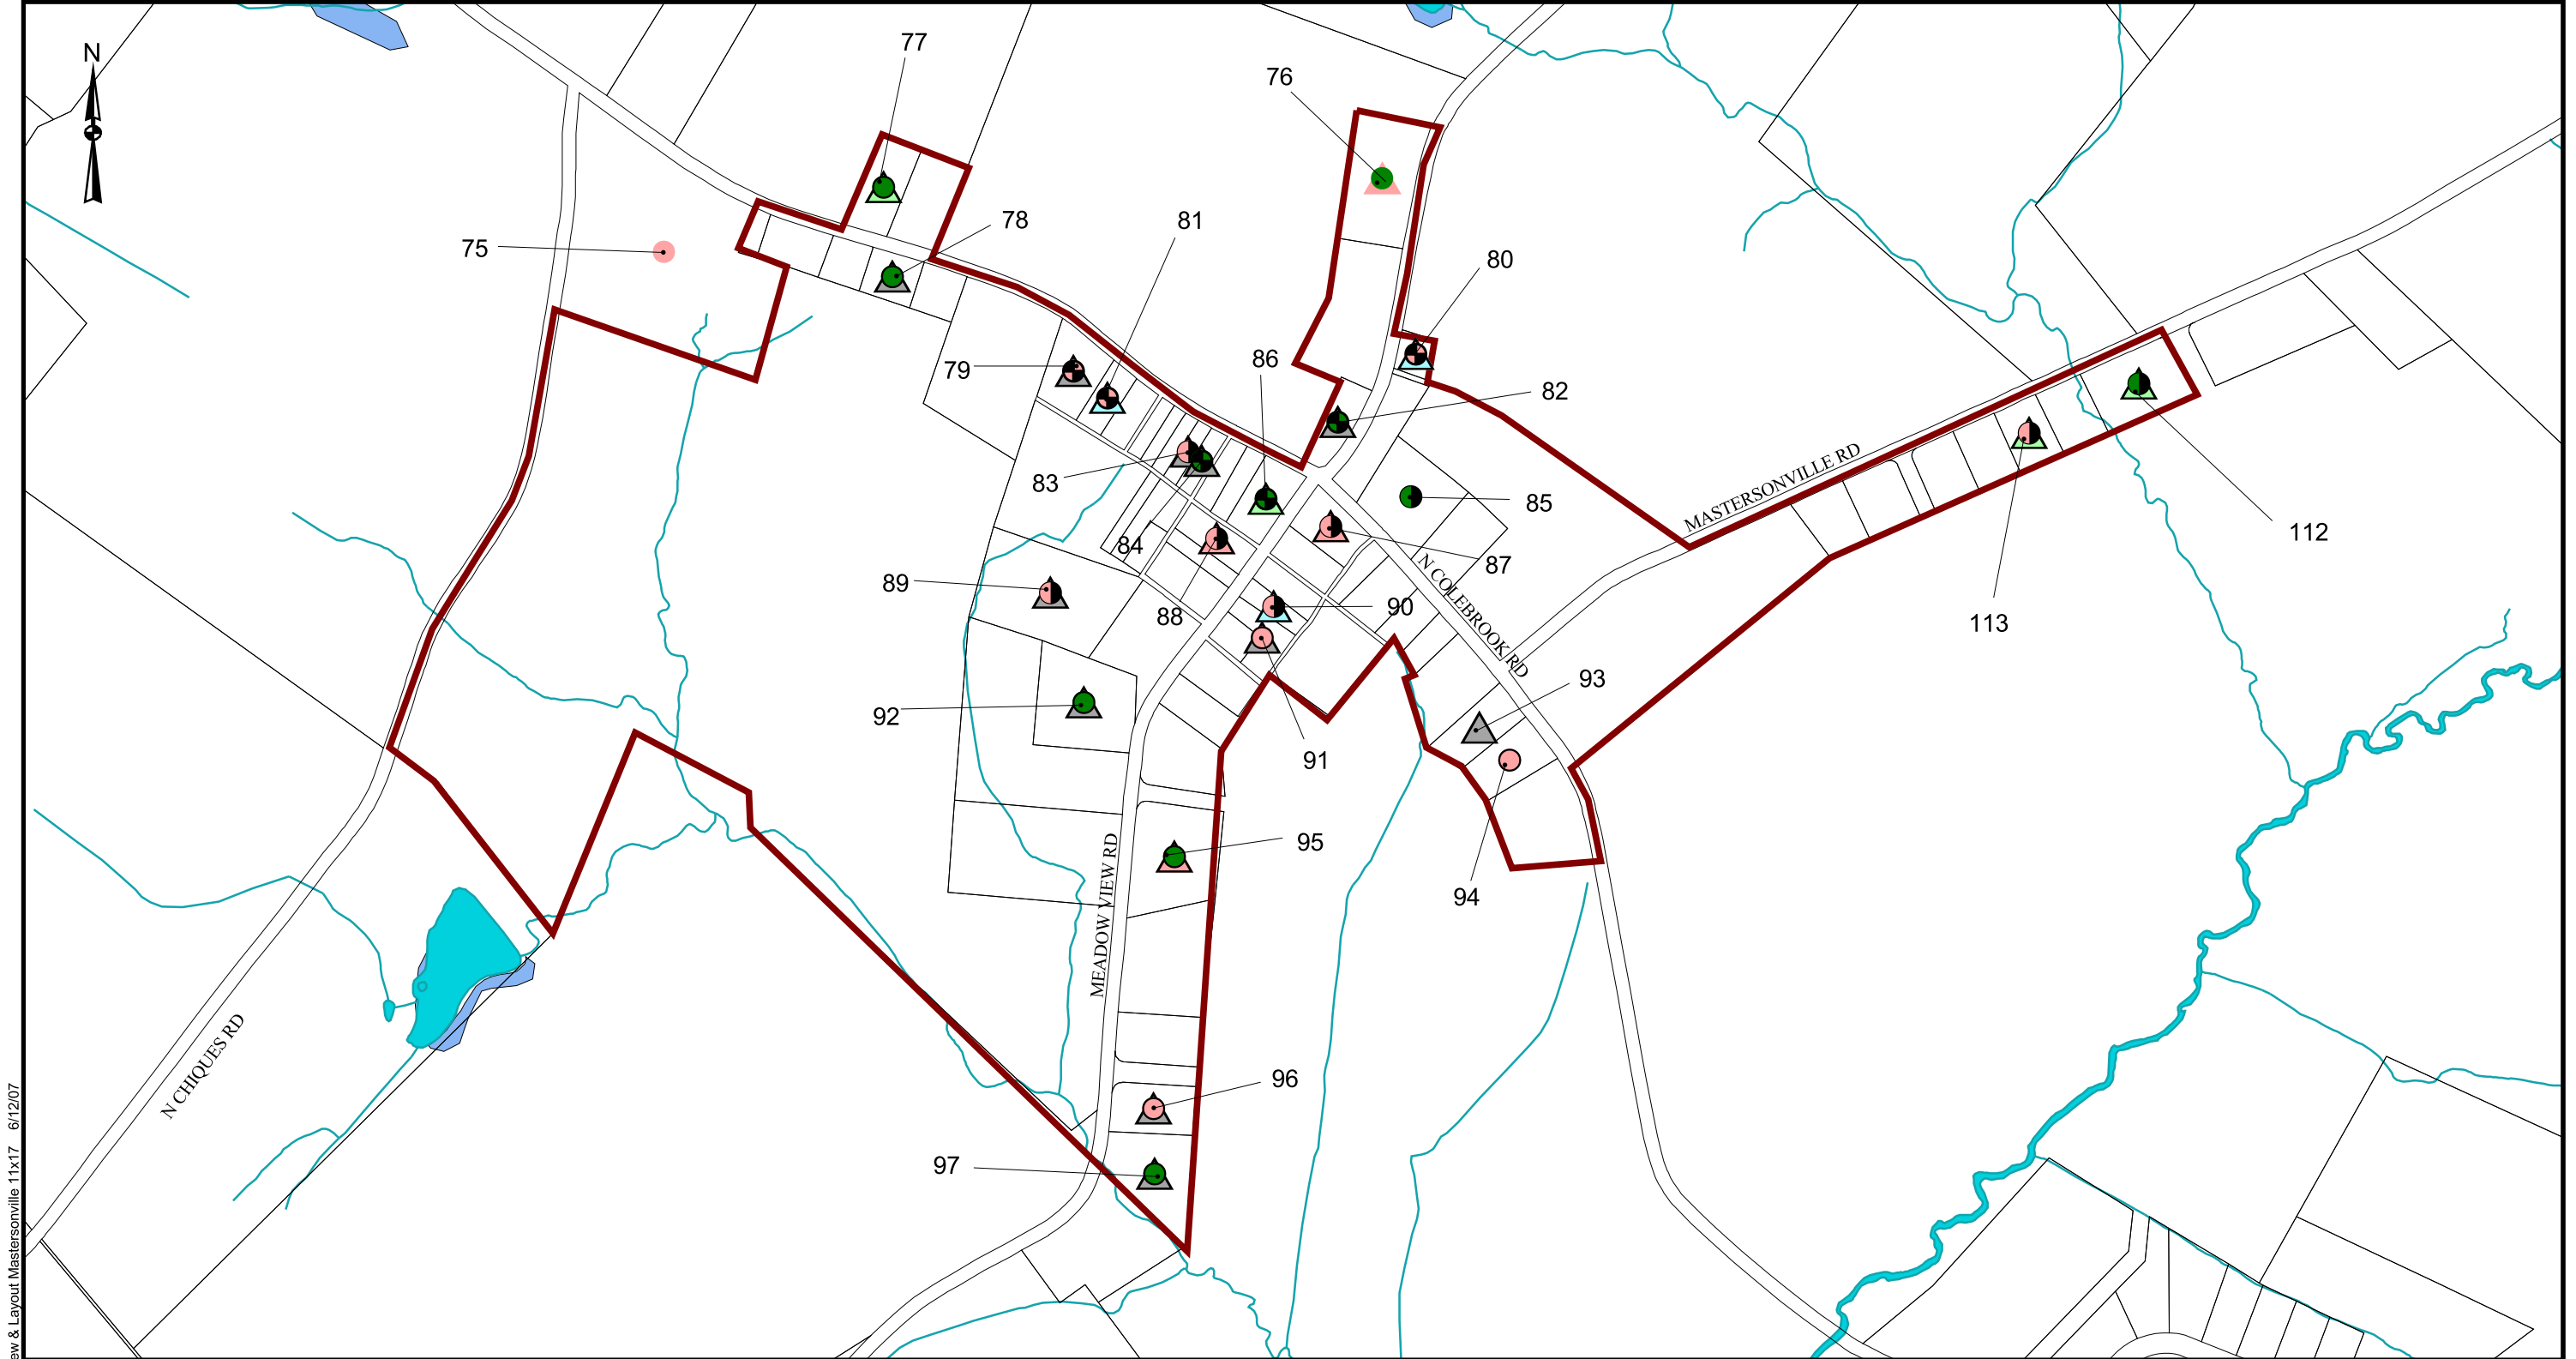
WELL RESULTS

- Wells with no Bacteria Detected and Nitrate Levels < 5 mg/l
- Wells with no Bacteria Detected and Nitrate Levels 5-10 mg/l
- Potential Malfunction Wells with no Bacteria Detected and Nitrate Levels > 10 mg/l
- Wells with Bacteria Detected and Nitrate Levels < 5 mg/l
- Wells with Bacteria Detected and Nitrate Levels 5-10 mg/l
- Potential Malfunction Wells with Bacteria Detected and Nitrate Levels > 10 mg/l

SANITARY SURVEY RESULTS

- Confirmed Malfunction
- Suspected Malfunction
- Potential Malfunction
- No Detected Malfunction
